**Flood Control Project Maintenance
Levee Inspections**
LMA District Cover Sheet
Spring 2018 Levee Inspection Results

Sacramento Maintenance Yard Maintenance Area 0009

Spring 2018 Levee Inspection Results

Waterway	Bank	Unit Miles
Unit No. 01 Sacramento River	Left	19.35

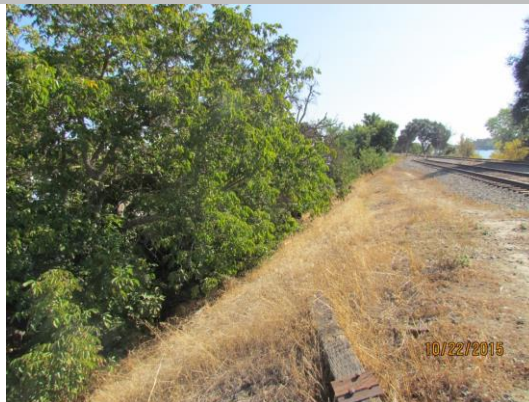
Photo 1 of 1 : SP_2018_MA0009_201_349_20180306_00283.jpg

LM Start	9.24	Rating **	M	Issue No.	349
LM End	9.24	Issue Type +	En	Location *	LS
Category	Earthen Levee			GPS Latitude/Longitude	
				Start	End
Item	Vegetation			38.462957 °	38.462957 °
				-121.502760 °	-121.502760 °
DWR ID	DWR_MA0009_01_f_2015_349				
Comment Code					
V6 : Landscaping					
Inspector Comment					
Tree is landscaped by the property owner. Visibility obstruction of levee slopes is not fully blocked.

View of the trees on the landward side of the levee looking downstream. Fall 2015.

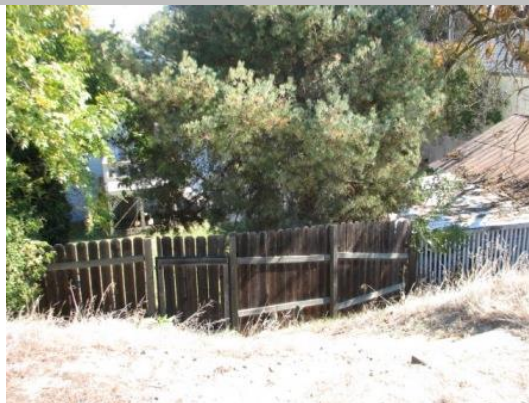
Photo 1 of 2 : SP_2018_MA0009_201_169_20180306_00122.jpg

LM Start	9.25	Rating **	U	Issue No.	169
LM End	9.25	Issue Type +	En	Location *	LS
Category	Earthen Levee			GPS Latitude/Longitude	
				Start	End
Item	Encroachments			38.462900 °	38.462900 °
				-121.502762 °	-121.502762 °
DWR ID	DWR_MA0009_01_s_2012_169				
Comment Code					
FE : Fence					
Inspector Comment

A solid wooden fence and building within the easement. Fall 2013

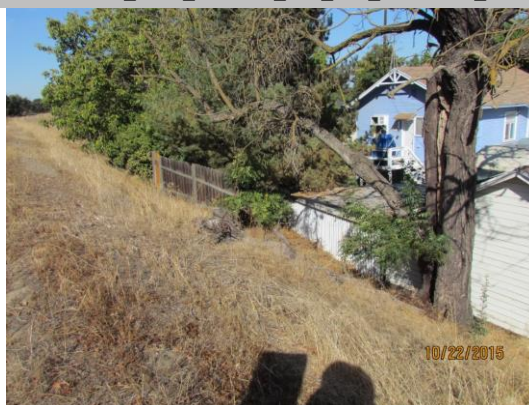
Photo 2 of 2 : SP_2018_MA0009_201_169_20180306_00123.jpg

View of the wooden fence and building on the landward side of the levee looking upstream. Fall 2015.

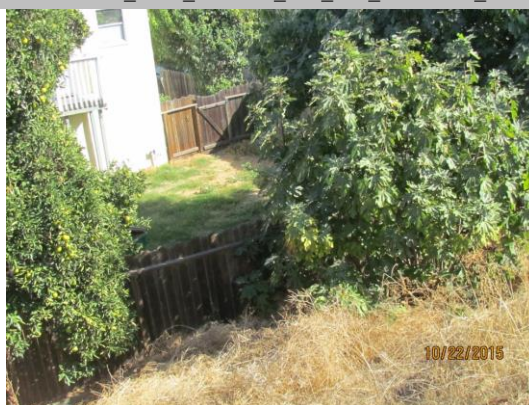
Photo 1 of 1 : SP_2018_MA0009_201_331_20180306_00264.jpg

LM Start	9.25	Rating **	U	Issue No.	331
LM End	9.25	Issue Type +	En	Location *	LS
Category	Earthen Levee			GPS Latitude/Longitude	
				Start	End
Item	Encroachments			38.462802 °	38.462802 °
				-121.502728 °	-121.502728 °
DWR ID	DWR_MA0009_01_f_2013_331				
Comment Code					
FE : Fence					
Inspector Comment

View of the fence and landscape at the toe of the levee on the landward side of the levee. Fall 2015.

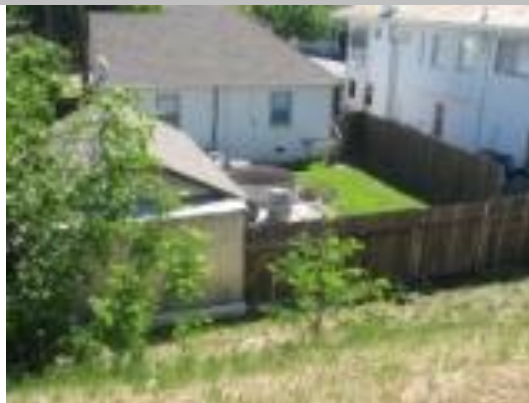
Photo 1 of 2 : SP_2018_MA0009_201_170_20180306_00124.jpg

LM Start	9.26	Rating **	M	Issue No.	170
LM End	9.26	Issue Type +	En	Location *	LS
Category	Earthen Levee			GPS Latitude/Longitude	
				Start	End
Item	Encroachments			38.462653 °	38.462653 °
				-121.502670 °	-121.502670 °
DWR ID	DWR_MA0009_01_s_2012_170				
Comment Code					
BU : Building					
Inspector Comment

A building at the toe. Spring 2013

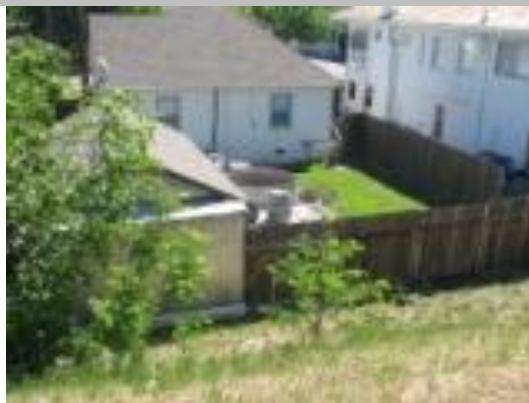
Photo 1 of 2 : SP_2018_MA0009_201_171_20180306_00126.jpg

LM Start	9.26	Rating **	U	Issue No.	171
LM End	9.26	Issue Type +	En	Location *	LS
Category	Earthen Levee			GPS Latitude/Longitude	
				Start	End
Item	Encroachments			38.462653 °	38.462653 °
				-121.502670 °	-121.502670 °
DWR ID	DWR_MA0009_01_s_2012_171				
Comment Code					
FE : Fence					
Inspector Comment

A fence along the toe. Spring 2013

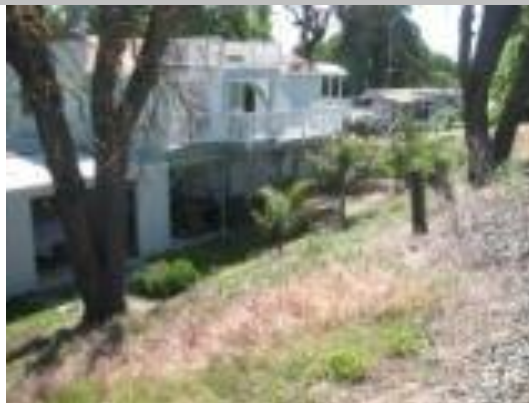
Photo 1 of 1 : SP_2018_MA0009_201_174_20180306_00130.jpg

LM Start	9.31	Rating **	M	Issue No.	174
LM End	9.31	Issue Type +	En	Location *	LS
Category	Earthen Levee			GPS Latitude/Longitude	
				Start	End
Item	Encroachments			38.462040 °	38.462040 °
				-121.502557 °	-121.502557 °
DWR ID	DWR_MA0009_01_s_2012_174				
Comment Code					
BU : Building					
Inspector Comment

A home is within the easement of the levee. Spring 2013

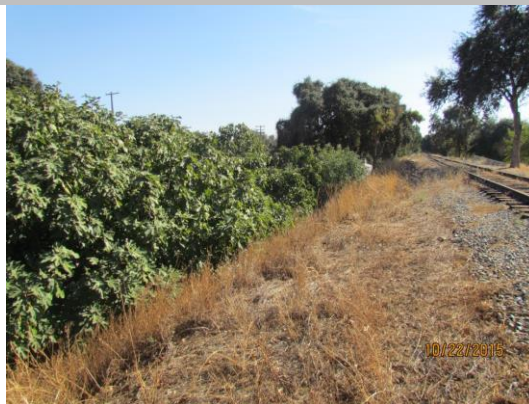
Photo 1 of 1 : SP_2018_MA0009_201_177_20180306_00133.jpg

LM Start	9.36	Rating **	M	Issue No.	177
LM End	9.36	Issue Type +	En	Location *	LS
Category	Earthen Levee			GPS Latitude/Longitude	
				Start	End
Item	Vegetation			38.461343 °	38.461343 °
				-121.502345 °	-121.502345 °
DWR ID	DWR_MA0009_01_s_2012_177				
Comment Code					
V6 : Landscaping					
Inspector Comment

View of the trees on the landward side of the levee looking downstream.
Fall 2015.

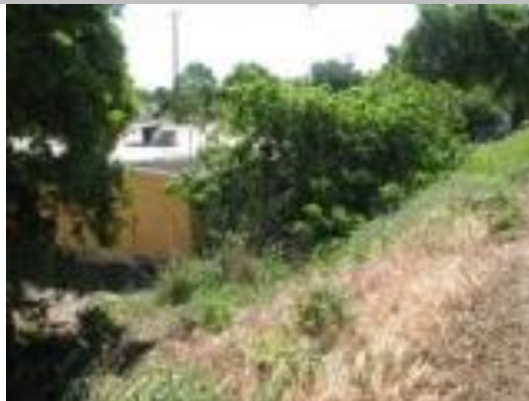
Photo 1 of 2 : SP_2018_MA0009_201_176_20180306_00131.jpg

LM Start	9.36	Rating **	M	Issue No.	176
LM End	9.36	Issue Type +	En	Location *	LS
Category	Earthen Levee			GPS Latitude/Longitude	
				Start	End
Item	Encroachments			38.461338 °	38.461338 °
				-121.502352 °	-121.502352 °
DWR ID	DWR_MA0009_01_s_2012_176				
Comment Code					
BU : Building					
Inspector Comment

The building is at the toe of the levee. Spring 2013

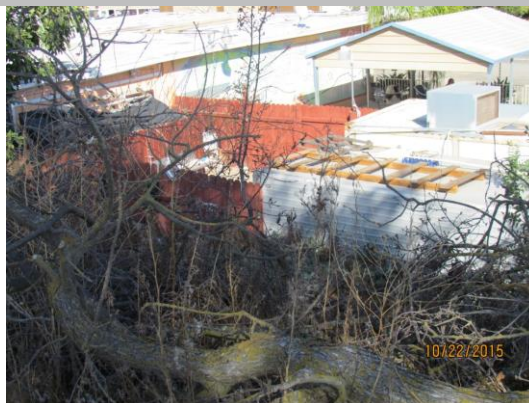
Photo 2 of 2 : SP_2018_MA0009_201_176_20180306_00132.jpg

View of the storage shed at the toe of the levee on the landward side.
Fall 2015.

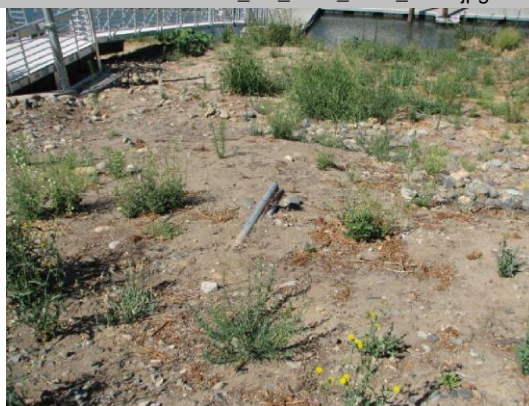
Photo 1 of 1 : UCIP_SP_2018_5903_8967.jpg

LM Start	9.39	Rating **	M	Issue No.	1795	
LM End	9.39	Issue Type +	En	Location *		
Category	Supplemental			GPS Latitude/Longitude		
				Start	End	
Item	DWR UCIP Field Study			38.460920 °	38.460920 °	
				-121.502220 °	-121.502220 °	
DWR ID						
Comment Code						
Inspector Comment						
FS_ID:5903						
DS_ID:18946						
EP_NO: N/A						
Repair Type: Non-Urgent						
Crossing Status: Found						
UCIP Comments: No permit identified for this crossing. Pipes should be removed or filled with grout.						
FIELD_STRUCT_DESC: 1 of 2: 2-inch galvanized steel pipe of an unknown purpose through the levee, 1.5 feet below the crown. Pipe open on both ends.						
FS Date: 6/21/2012 2:57:40 PM

View of pipe from WS shoulder looking towards river.

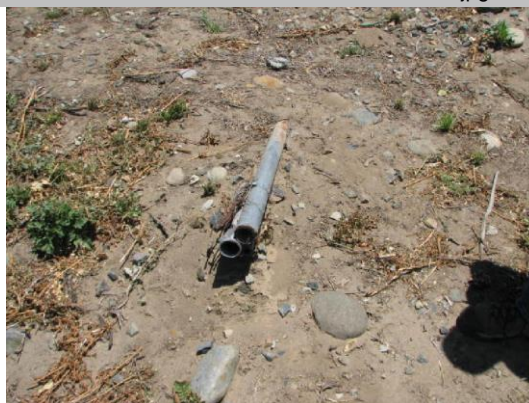
Photo 1 of 2 : UCIP_SP_2018_5904_8969.jpg

LM Start	9.39	Rating **	M	Issue No.	1796
LM End	9.39	Issue Type +	En	Location *	
Category	Supplemental			GPS Latitude/Longitude	
				Start	End
Item	DWR UCIP Field Study			38.460920 °	38.460920 °
				-121.502220 °	-121.502220 °
DWR ID					
Comment Code					
Inspector Comment					
FS_ID:5904					
DS_ID:18947					
EP_NO: N/A					
Repair Type: Non-Urgent					
Crossing Status: Found					
UCIP Comments: No permit identified for this crossing. Pipe should be removed or grouted in place.					
FIELD_STRUCT_DESC: 2 of 2: 2-inch galvanized steel pipe of an unknown purpose through the levee, 1.5 feet below the crown. Pipe open on both ends.					
FS Date: 6/21/2012

Pipe on WS shoulder.

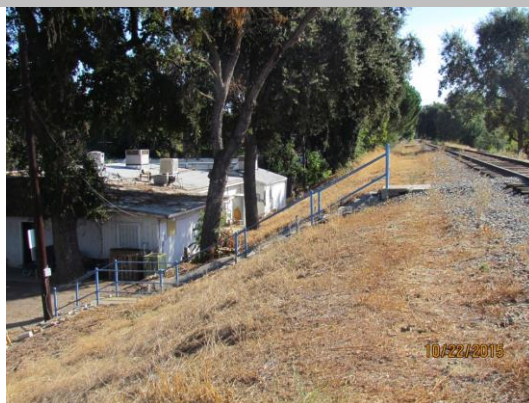
Photo 1 of 1 : SP_2018_MA0009_201_178_20180306_00134.jpg

LM Start	9.40	Rating **	M	Issue No.	178
LM End	9.40	Issue Type +	En	Location *	LS
Category	Earthen Levee			GPS Latitude/Longitude	
				Start	End
Item	Encroachments			38.460772 °	38.460772 °
				-121.502170 °	-121.502170 °
DWR ID	DWR_MA0009_01_s_2012_178				
Comment Code					
BU : Building					
Inspector Comment

View of the building within the easement on the landward side of the levee looking downstream. Fall 2015.

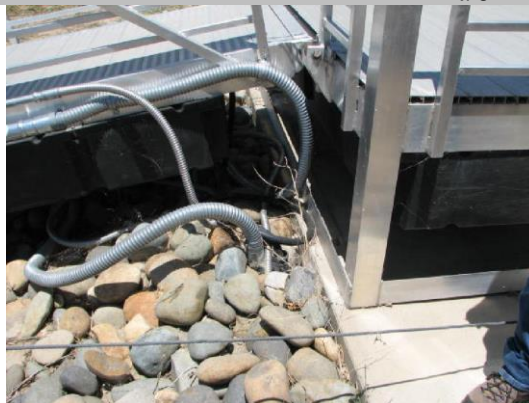
Photo 1 of 3 : UCIP_SP_2018_5905_8972.jpg

LM Start	9.40	Rating **	M	Issue No.	1797	
LM End	9.40	Issue Type +	En	Location *		
Category	Supplemental			GPS Latitude/Longitude		
				Start	End	
Item	DWR UCIP Field Study			38.460670 °	38.460670 °	
				-121.502140 °	-121.502140 °	
DWR ID						
Comment Code						
Inspector Comment						
FS_ID:5905 DS_ID:18948 EP_NO: N/A Repair Type: Non-Urgent Crossing Status: Found UCIP Comments: No permit identified for this crossing. Likely that this is a service line that provides power for the boat dock. FIELD_STRUCT_DESC: Christie box on the waterside (WS) shoulder. Possibly a utility crossing connecting to an electrical panel on the building at the landside (LS) toe. Pipe not visible. FS Date: 6/21/2012 3:04:17 PM

Likely that the pipes at the boat walkway cross at the christie box.

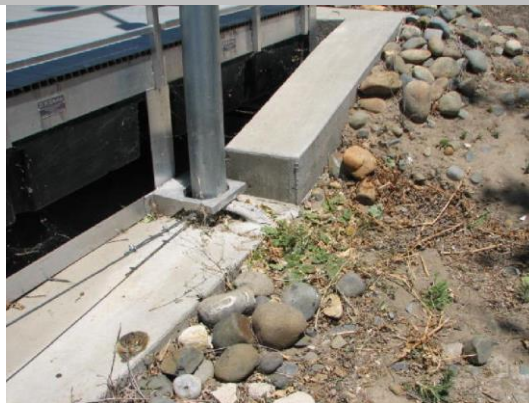
Photo 2 of 3 : UCIP_SP_2018_5905_8971.jpg

Likely that the pipes at the boat walkway cross at the christie box.

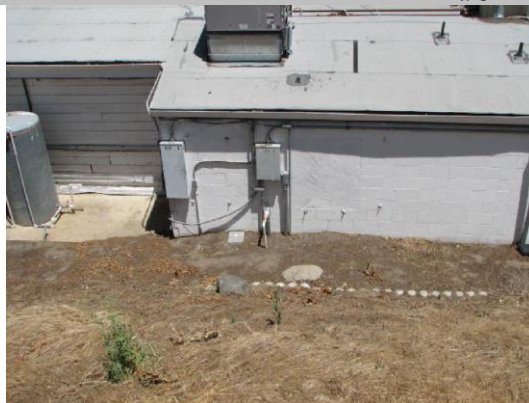
Photo 3 of 3 : UCIP_SP_2018_5905_8970.jpg

LM Start	9.40	Rating **	M	Issue No.	1797 (cont)	
LM End	9.40	Issue Type +	En	Location *		
Category	Supplemental			GPS Latitude/Longitude		
				Start	End	
Item	DWR UCIP Field Study			38.460670 °	38.460670 °	
				-121.502140 °	-121.502140 °	
DWR ID						
Comment Code						
Inspector Comment						
FS_ID:5905 DS_ID:18948 EP_NO: N/A Repair Type: Non-Urgent Crossing Status: Found UCIP Comments: No permit identified for this crossing. Likely that this is a service line that provides power for the boat dock. FIELD_STRUCT_DESC: Christie box on the waterside (WS) shoulder. Possibly a utility crossing connecting to an electrical panel on the building at the landside (LS) toe. Pipe not visible. FS Date: 6/21/2012 3:04:17 PM

Likely that the pipes at the fuse box on the LS toe building cross at the christie box to serve boat dock.

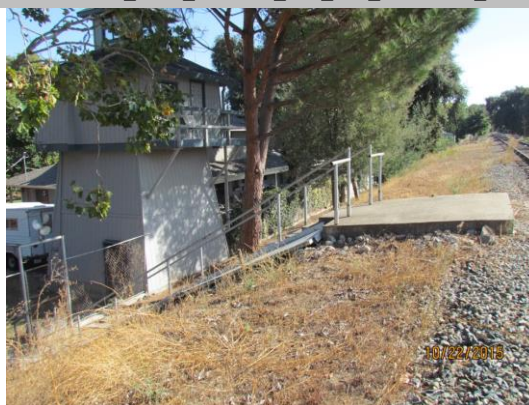
Photo 1 of 1 : SP_2018_MA0009_201_180_20180306_00137.jpg

LM Start	9.44	Rating **	M	Issue No.	180
LM End	9.44	Issue Type +	En	Location *	LS
Category	Earthen Levee			GPS Latitude/Longitude	
				Start	End
Item	Encroachments			38.460210 °	38.460210 °
				-121.502030 °	-121.502030 °
DWR ID	DWR_MA0009_01_s_2012_180				
Comment Code					
BU : Building					
Inspector Comment

View of the building within the easement on the landward side of the levee looking downstream. Fall 2015.

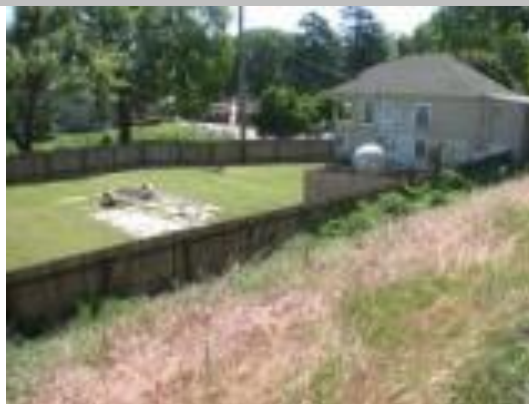
Photo 1 of 2 : SP_2018_MA0009_201_181_20180306_00138.jpg

LM Start	9.48	Rating **	U	Issue No.	181
LM End	9.52	Issue Type +	En	Location *	LS
Category	Earthen Levee			GPS Latitude/Longitude	
				Start	End
Item	Encroachments			38.459665 °	38.458993 °
				-121.501847 °	-121.501642 °
DWR ID	DWR_MA0009_01_s_2012_181				
Comment Code					
FE : Fence					
Inspector Comment

The fence continues along the toe. Spring 2013

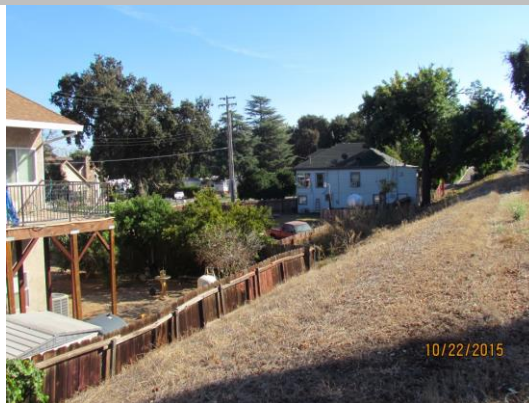
Photo 2 of 2 : SP_2018_MA0009_201_181_20180306_00139.jpg

LM Start	9.48	Rating **	U	Issue No.	181 (cont)	
LM End	9.52	Issue Type +	En	Location *	LS	
Category	Earthen Levee			GPS Latitude/Longitude		
				Start		End
Item	Encroachments			38.459665 °		38.458993 °
				-121.501847 °		-121.501642 °
DWR ID	DWR_MA0009_01_s_2012_181					
Comment Code						
FE : Fence						
Inspector Comment

View of the fence along the toe of the levee on the landward side looking downstream. Fall 2015.

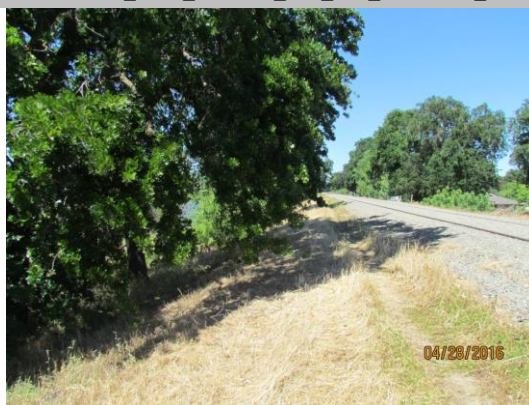
Photo 1 of 1 : SP_2018_MA0009_201_380_20180306_00305.jpg

LM Start	9.50	Rating **	A/W	Issue No.	380
LM End	9.50	Issue Type +	Ma	Location *	WS
Category	Earthen Levee			GPS Latitude/Longitude	
				Start	End
Item	Trim / Thin Trees			38.459358 °	38.459358 °
				-121.501770 °	-121.501770 °
DWR ID	DWR_MA0009_01_s_2016_380				
Comment Code					
T1 : Trim trees to at least five feet above ground level.					
Inspector Comment

View of the trees on the waterward side of the levee looking upstream. Spring 2016.

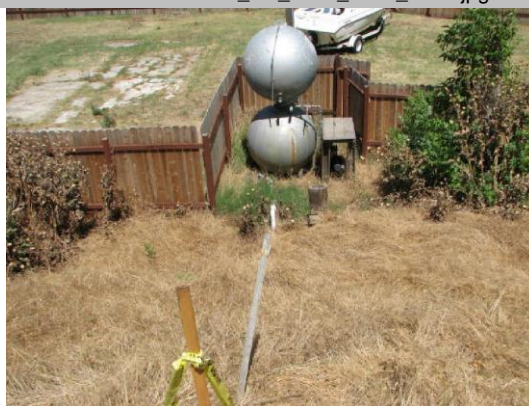
Photo 1 of 2 : UCIP_SP_2018_5907_8976.jpg

LM Start	9.52	Rating **	M	Issue No.	1798
LM End	9.52	Issue Type +	En	Location *	
Category	Supplemental			GPS Latitude/Longitude	
				Start	End
Item	DWR UCIP Field Study			38.459110 °	38.459110 °
				-121.501660 °	-121.501660 °
DWR ID					
Comment Code					
Inspector Comment					
FS_ID:5907 DS_ID:18952 EP_NO: N/A Repair Type: Non-Urgent Crossing Status: Found UCIP Comments: No permit identified for this crossing. FIELD_STRUCT_DESC: 2-inch polyvinyl chloride (PVC) water line through the levee, 3 feet below the crown. Pump and tank system on the landside (LS) toe. FS Date: 6/21/2012 3:12:50 PM

Pipe runs down LS slope to tank and pump at LS toe.

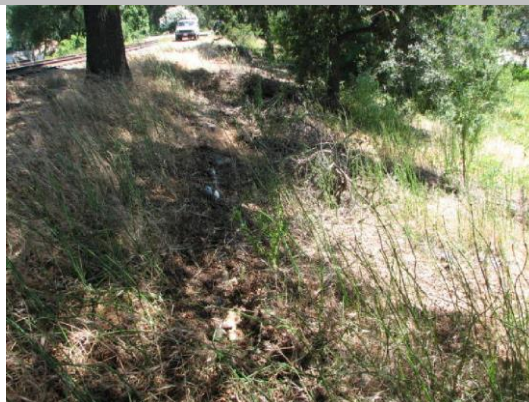
Photo 2 of 2 : UCIP_SP_2018_5907_8975.jpg

Pipe runs downstream parallel to levee crown just under the surface towards marina.

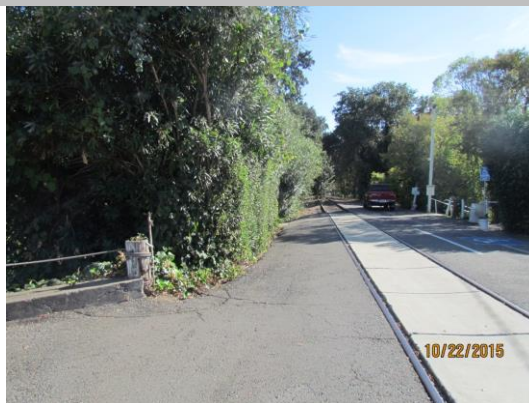
Photo 1 of 1 : SP_2018_MA0009_201_185_20180306_00144.jpg

LM Start	9.58	Rating **	U	Issue No.	185
LM End	9.60	Issue Type +	En	Location *	LS
Category	Earthen Levee			GPS Latitude/Longitude	
				Start	End
Item	Vegetation			38.458242 °	38.457873 °
				-121.501340 °	-121.501290 °
DWR ID	DWR_MA0009_01_s_2012_185				
Comment Code					
V6 : Landscaping					
Inspector Comment

View of the trees and shrubs on the landward side of the levee looking downstream. Fall 2015.

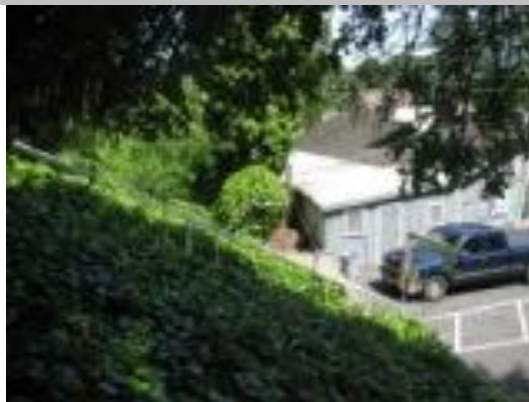
Photo 1 of 2 : SP_2018_MA0009_201_184_20180306_00142.jpg

LM Start	9.59	Rating **	M	Issue No.	184
LM End	9.59	Issue Type +	En	Location *	LS
Category	Earthen Levee			GPS Latitude/Longitude	
				Start	End
Item	Encroachments			38.458078 °	38.458078 °
				-121.501367 °	-121.501367 °
DWR ID	DWR_MA0009_01_f_2017_184				
Comment Code					
BU : Building					
Inspector Comment					
Freeport bait shop.

The Freeport Bait shop is at the toe of the levee. Photo taken spring 2012.

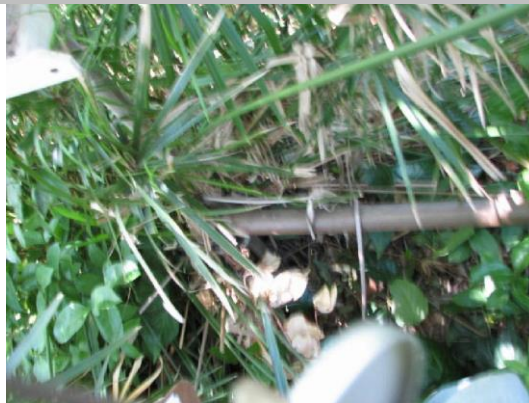
Photo 1 of 3 : UCIP_SP_2018_5107_6816.jpg

LM Start	9.59	Rating **	M	Issue No.	1803
LM End	9.59	Issue Type +	En	Location *	
Category	Supplemental			GPS Latitude/Longitude	
				Start	End
Item	DWR UCIP Field Study			38.458010 °	38.458010 °
				-121.501320 °	-121.501320 °
DWR ID					
Comment Code					
Inspector Comment					
FS_ID:5107 DS_ID:17646 EP_NO: N/A Repair Type: Non-Urgent Crossing Status: Found UCIP Comments: Due to the amount of utilities in this area it is unclear if any are authorized. This area needs to be cleared of vegetation and thoroughly searched for utility crossings. FIELD_STRUCT_DESC: 2 of 6: 2-inch drain pipe through levee, 3 feet below crown. Main valve in box on waterward slope. Found 1.5-inch steel pipe near this location just upstream of stairs on WS of levee 1.5 feet below crown. FS Date: 6/21/2012 12:59:07 PM

Pipe on WS slope just upstream from stairs.

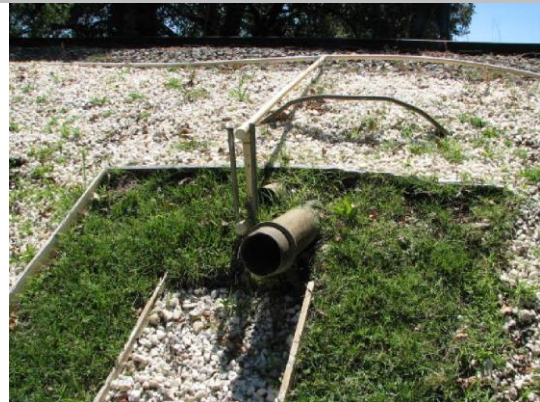
Photo 1 of 3 : UCIP_SP_2018_51247_20793.jpg

Comment Code						
Inspector Comment						
FS_ID:51247 DS_ID:18950 EP_NO: N/A Repair Type: Urgent Crossing Status: Found UCIP Comments: 12/01/2016 same as last inspection conduit is open through the levee. Unable to locate WS daylight due to dense vegetation. Need to contact owner to determine status of crossing. If crossing is abandoned, owner will need to coordinate with the CVFPB to comply with Title 23. (O. Magana - DWR UCIP)06/21/2012 Open conduit through the levee. No permit identified for this crossing. (W. Wylie - DWR UCIP) FIELD_STRUCT_DESC: 1 of 2: 5-inch galvanized steel water pipe through the levee, 3 feet below the crown. Pipe open on both ends. FS Date: 12/2/2016

Pipe through freeport marina grass sign.

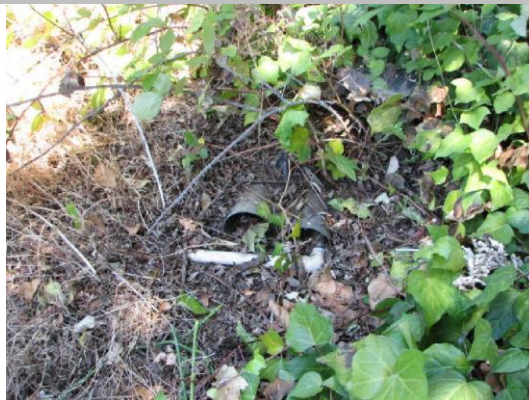
Photo 3 of 3 : UCIP_SP_2018_51247_20791.jpg

Both pipes on WS shoulder.

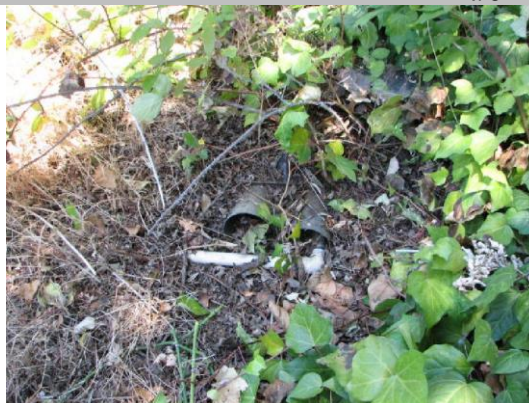
Photo 3 of 3 : UCIP_SP_2018_51248_20794.jpg

Comment Code						
Inspector Comment						
FS_ID:51248 DS_ID:18951 EP_NO: N/A Repair Type: Urgent Crossing Status: Found UCIP Comments: 12/02/2016 same as last inspection conduit is open through the levee. Unable to locate WS daylight due to dense vegetation. Need to contact owner to determine status of crossing. If crossing is abandoned, owner will need to coordinate with the CVFPB to comply with Title 23. (O. Magana - DWR UCIP)06/21/2012 Pipe open on both ends. No permit identified for this crossing. (W. Wylie - DWR UCIP) FIELD_STRUCT_DESC: 2 of 2: 5-inch galvanized steel water pipe through the levee, 3 feet below the crown. Pipe open on both ends. FS Date: 12/2/2016

both pipes on WS shoulder.

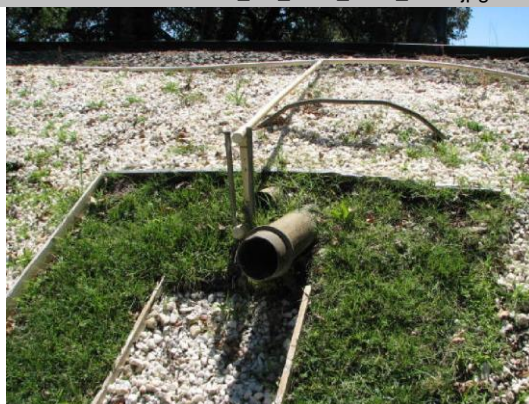
Photo 1 of 1 : UCIP_SP_2018_5112_6821.jpg

LM Start	9.61	Rating **	M	Issue No.	1809
LM End	9.61	Issue Type +	En	Location *	
Category	Supplemental			GPS Latitude/Longitude	
				Start	End
Item	DWR UCIP Field Study			38.457723 °	38.457723 °
				-121.501230 °	-121.501230 °
DWR ID					
Comment Code					
Inspector Comment					
FS_ID:5112 DS_ID:17650 EP_NO: N/A Repair Type: Non-Urgent Crossing Status: Found UCIP Comments: Due to the amount of utilities in this area it is unclear if any are authorized. This area needs to be cleared of vegetation and thoroughly searched for utility crossings. FIELD_STRUCT_DESC: 6 of 6: 0.5-inch galvanized steel water line riser with water spigot on the landside (LS) shoulder. [Additional Reference(s): DWR Levee Log, 1991]. FS Date: 6/21/2012 1:11:00 PM

bent metal pipe at center leads to spigot at other end of Freeport Marina grass and gravel sign.

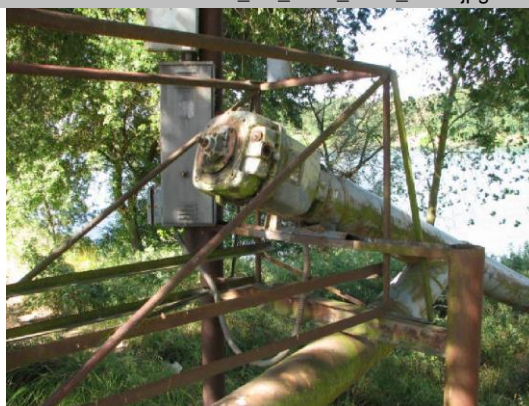
Photo 2 of 3 : UCIP_SP_2018_5117_6829.jpg

LM Start	9.80	Rating **	M	Issue No.	1811 (cont)	
LM End	9.80	Issue Type +	En	Location *		
Category	Supplemental			GPS Latitude/Longitude		
				Start	End	
Item	DWR UCIP Field Study			38.455040 °	38.455040 °	
				-121.500450 °	-121.500450 °	
DWR ID						
Comment Code						
Inspector Comment						
FS_ID:5117						
DS_ID:17439						
EP_NO: N/A						
Repair Type: Non-Urgent						
Crossing Status: Found						
UCIP Comments: Walkway unsafe and could pose attractive nuisance to minors. Walkway should be repaired or removed.						
FIELD_STRUCT_DESC: 14-inch pipe through levee, 7.2 feet below crown. Pump on pile structure in stream. Overhead power line crosses levee to pole and meter next to pump. Ramp on landward slope. Permit No. 1449, 1949. Included in O+M manual (1955).						
FS Date: 6/22/2012 1:36:29 PM

Pump next to meter on pole, WS.

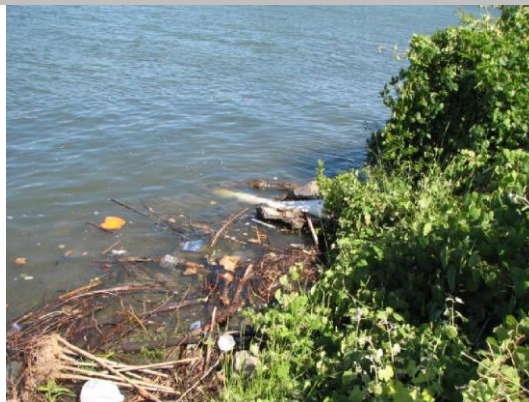
Photo 2 of 2 : UCIP_SP_2018_5920_9001.jpg

Pipe on WS toe at river.

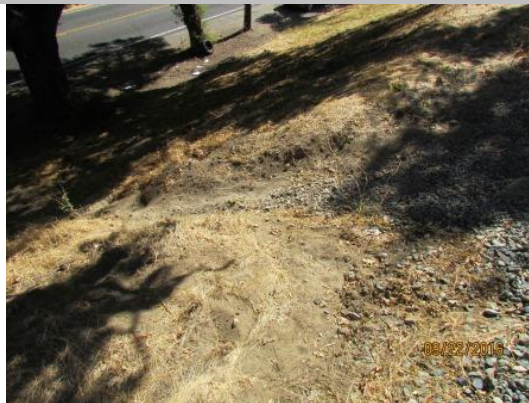
Photo 1 of 2 : SP_2018_MA0009_201_361_20180306_00291.jpg

LM Start	9.94	Rating **	A/W	Issue No.	361
LM End	9.94	Issue Type +	Ma	Location *	LS
Category	Earthen Levee			GPS Latitude/Longitude	
				Start	End
Item	Slope Stability			38.453095 °	38.453095 °
				-121.500147 °	-121.500147 °
DWR ID	DWR_MA0009_01_f_2015_361				
Comment Code					
S2 : Repair the levee slope damaged by foot traffic and prevent access where possible.					
Inspector Comment

An update view of a footpath on LS slope of the levee. Fall 2016.

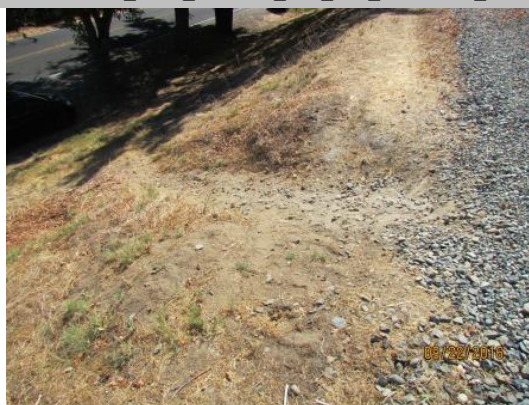
Photo 1 of 2 : SP_2018_MA0009_201_362_20180306_00293.jpg

LM Start	9.96	Rating **	A/W	Issue No.	362
LM End	9.96	Issue Type +	Ma	Location *	LS
Category	Earthen Levee			GPS Latitude/Longitude	
				Start	End
Item	Slope Stability			38.452728 °	38.452728 °
				-121.500100 °	-121.500100 °
DWR ID	DWR_MA0009_01_f_2015_362				
Comment Code					
S2 : Repair the levee slope damaged by foot traffic and prevent access where possible.					
Inspector Comment

Updated view of a footpath on LS slope of the levee. Fall 2016.

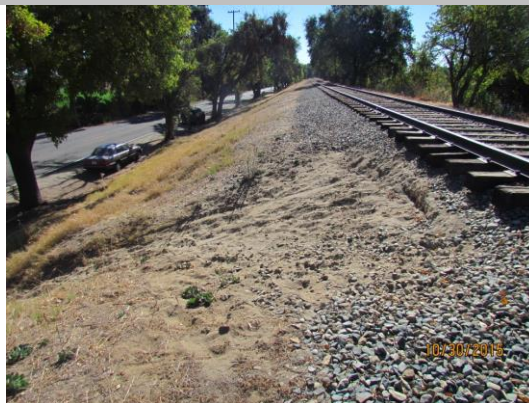
Photo 1 of 1 : SP_2018_MA0009_201_365_20180306_00295.jpg

LM Start	10.05	Rating **	M	Issue No.	365
LM End	10.05	Issue Type +	Ma	Location *	LS
Category	Earthen Levee			GPS Latitude/Longitude	
				Start	End
Item	Erosion / Bank Caving			38.451468 °	38.451468 °
				-121.500030 °	-121.500030 °
DWR ID	DWR_MA0009_01_f_2015_365				
Comment Code					
E1 : Note and monitor erosion site.					
Inspector Comment					
Erosion due to runoff that is undermining railroad tracks.

View of the slope stability on the landward side of the levee looking downstream. Fall 2015.

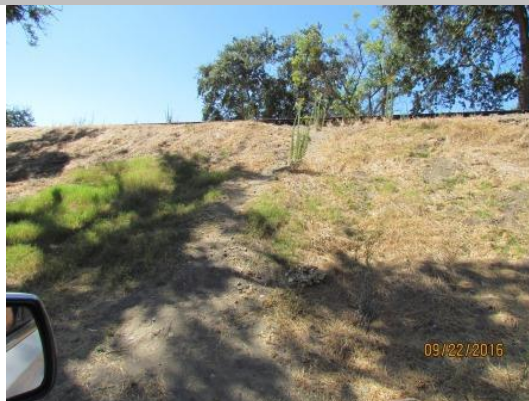
Photo 1 of 2 : SP_2018_MA0009_201_381_20180306_00306.jpg

LM Start	10.12	Rating **	M	Issue No.	381
LM End	10.12	Issue Type +	Ma	Location *	LS
Category	Earthen Levee			GPS Latitude/Longitude	
				Start	End
Item	Slope Stability			38.450427 °	38.450427 °
				-121.500032 °	-121.500032 °
DWR ID	DWR_MA0009_01_s_2016_381				
Comment Code					
S3 : Repair the levee slope damaged by vehicle traffic and prevent access where possible.					
Inspector Comment

View from Hwy 160 on slope stability site on LS slope of the levee. Fall 2016.

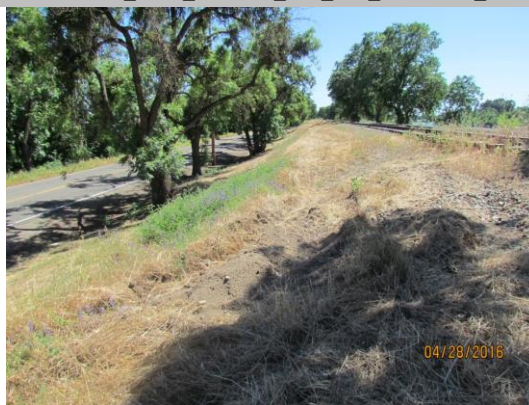
Photo 2 of 2 : SP_2018_MA0009_201_381_20180306_00307.jpg

View of the slope stability on the landward side of the levee looking downstream. Spring 2016.

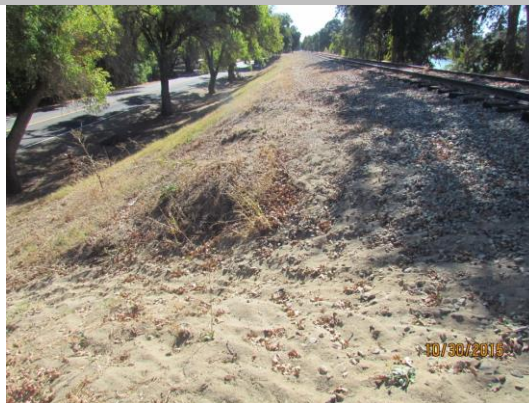
Photo 1 of 1 : SP_2018_MA0009_201_368_20180306_00299.jpg

LM Start	10.15	Rating **	M	Issue No.	368
LM End	10.15	Issue Type +	Ma	Location *	LS
Category	Earthen Levee			GPS Latitude/Longitude	
				Start	End
Item	Slope Stability			38.449967 °	38.449967 °
				-121.500053 °	-121.500053 °
DWR ID	DWR_MA0009_01_f_2015_368				
Comment Code					
S2 : Repair the levee slope damaged by foot traffic and prevent access where possible.					
Inspector Comment

View of the slope stability on the landward side of the levee looking downstream. Fall 2015.

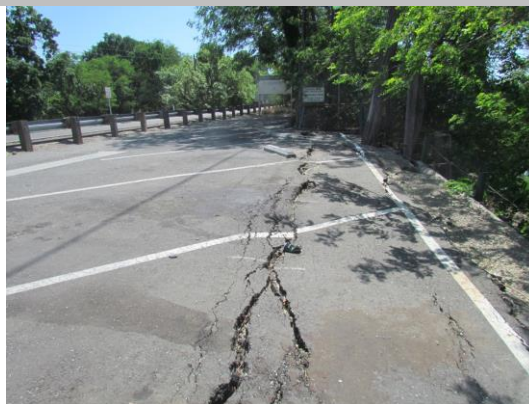
Photo 1 of 1 : SP_2018_MA0009_201_309_20180306_00246.jpg

LM Start	10.54	Rating **	M	Issue No.	309
LM End	10.54	Issue Type +	Ob	Location *	WS
Category	Earthen Levee			GPS Latitude/Longitude	
				Start	End
Item	Cracking			38.444353 °	38.444353 °
				-121.500472 °	-121.500472 °
DWR ID	DWR_MA0009_01_s_2015_309				
Comment Code					
CR1 : Monitor and have inspected by geotechnical engineer.					
Inspector Comment

View of the crack on the water ward side of the levee looking downstream. Spring 2015.

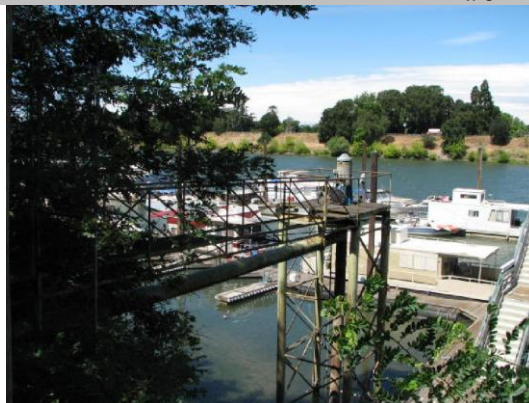
Photo 1 of 3 : UCIP_SP_2018_9443_16422.jpg

LM Start	10.56	Rating **	M	Issue No.	1814
LM End	10.56	Issue Type +	En	Location *	
Category	Supplemental			GPS Latitude/Longitude	
				Start	End
Item	DWR UCIP Field Study			38.444136 °	38.444136 °
				-121.500414 °	-121.500414 °
DWR ID					
Comment Code					
Inspector Comment					
FS_ID:9443 DS_ID:18957 EP_NO: N/A Repair Type: Non-Urgent Crossing Status: Found UCIP Comments: No permit identified for this crossing. FIELD_STRUCT_DESC: 14-inch steel irrigation pipe through the levee, 3.5 feet below the crown. Pump on elevated pier with elevated walkway on the waterside (WS) shoulder. 48-inch concrete distribution box on the landside (LS) toe. (Permit No. 1629, 1952 - C. A. Beach). FS Date: 6/22/2012 3:46:00 PM

Pump on elevated pier on WS.

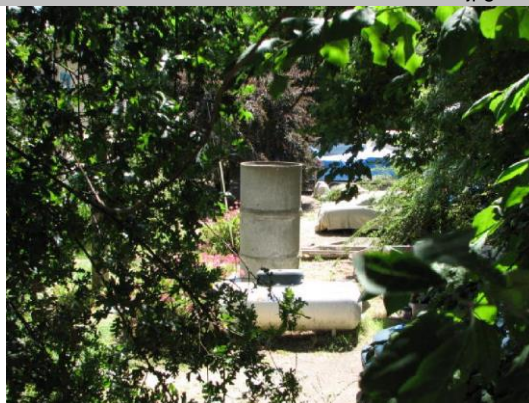
Photo 2 of 3 : UCIP_SP_2018_9443_16423.jpg

Concrete Standpipe on LS in homeowners yard.

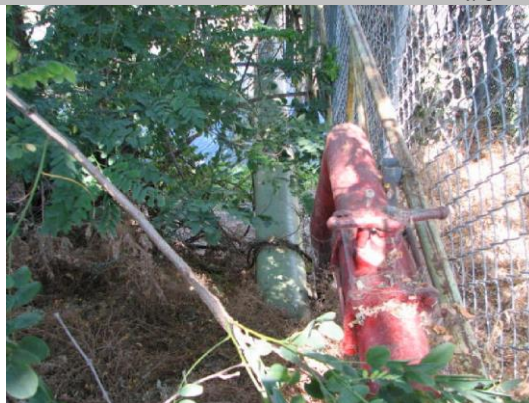
Photo 3 of 3 : UCIP_SP_2018_9443_16424.jpg

Pipe, Fire Connection, and Fenced in Walway on WS shoulder.

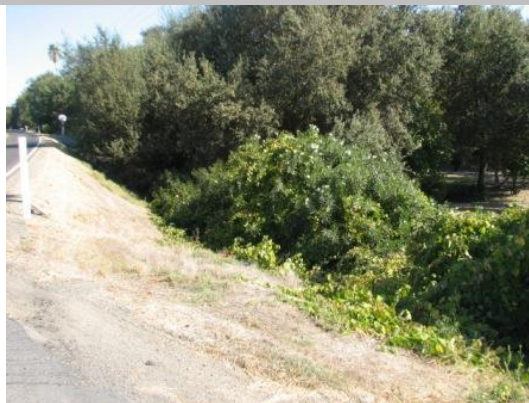
Photo 1 of 2 : SP_2018_MA0009_201_220_20180306_00166.jpg

LM Start	10.77	Rating **	M	Issue No.	220
LM End	10.77	Issue Type +	En	Location *	LS
Category	Earthen Levee			GPS Latitude/Longitude	
				Start	End
Item	Vegetation			38.441133 °	38.441133 °
				-121.501632 °	-121.501632 °
DWR ID	DWR_MA0009_01_s_2012_220				
Comment Code					
V6 : Landscaping					
Inspector Comment

The over grown landscape blocks visibility. Fall 2013

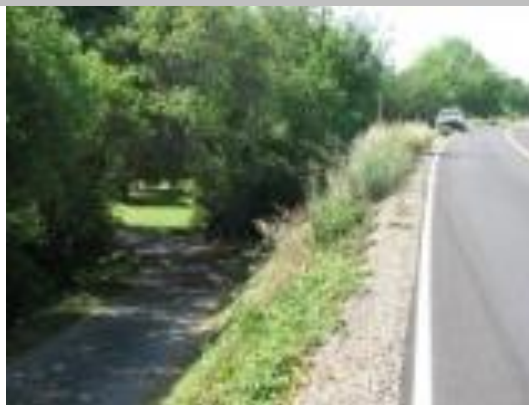
Photo 2 of 2 : SP_2018_MA0009_201_220_20180306_00167.jpg

A view of the drive and landscape. Photo taken spring 2012.

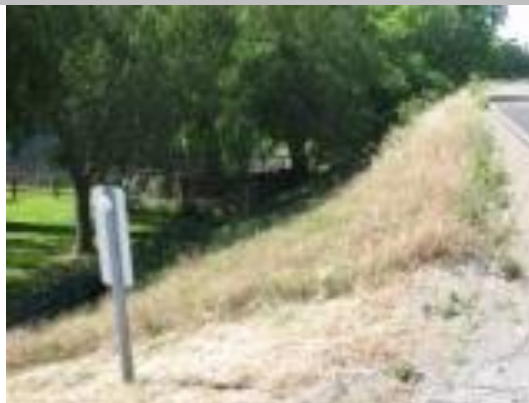
Photo 1 of 1 : SP_2018_MA0009_201_219_20180306_00165.jpg

LM Start	10.82	Rating **	M	Issue No.	219
LM End	10.82	Issue Type +	En	Location *	LS
Category	Earthen Levee			GPS Latitude/Longitude	
				Start	End
Item	Vegetation			38.440577 °	38.440577 °
				-121.502058 °	-121.502058 °
DWR ID	DWR_MA0009_01_s_2012_219				
Comment Code					
V6 : Landscaping					
Inspector Comment

A view of the horse corral and some landscape. Photo taken spring 2012.

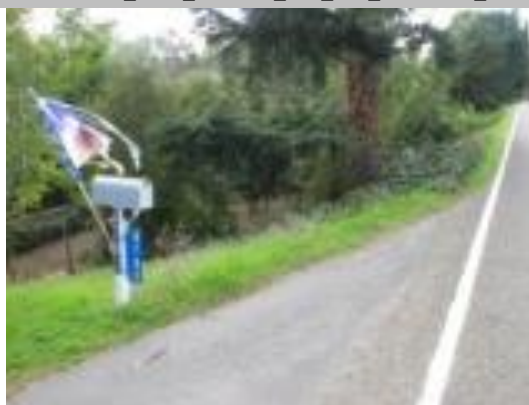
Photo 1 of 1 : SP_2018_MA0009_201_160_20180306_00111.jpg

LM Start	10.96	Rating **	M	Issue No.	160
LM End	10.96	Issue Type +	En	Location *	LS
Category	Earthen Levee			GPS Latitude/Longitude	
				Start	End
Item	Vegetation			38.438883 °	38.438883 °
				-121.503654 °	-121.503654 °
DWR ID	DWR_MA0009_01_f_2012_160				
Comment Code					
V6 : Landscaping					
Inspector Comment

Groundcover and shrubs on the slope and toe of levee. Fall 2012

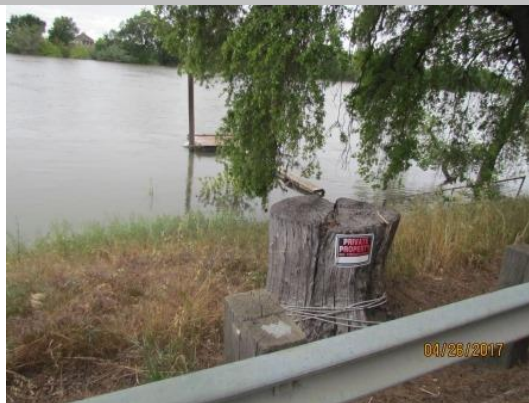
Photo 1 of 1 : SP_2018_MA0009_201_306_20180306_00245.jpg

LM Start	11.02	Rating **	N	Issue No.	306
LM End	11.02	Issue Type +	Ma	Location *	WS
Category	Earthen Levee			GPS Latitude/Longitude	
				Start	End
Item	Trim / Thin Trees			38.438314 °	38.438314 °
				-121.504306 °	-121.504306 °
DWR ID	DWR_MA0009_01_s_2017_306				
Comment Code					
T5 : Tree stumps.					
Inspector Comment

View of stump on waterside levee slope. Spring 2017.

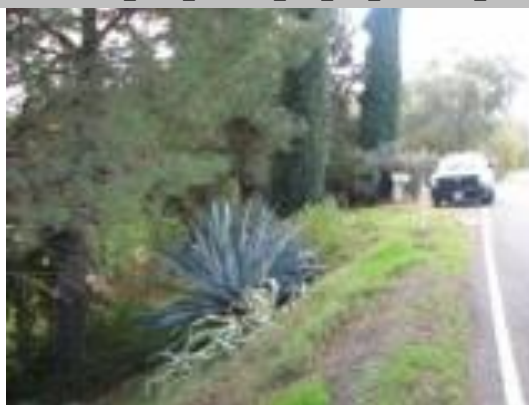
Photo 1 of 1 : SP_2018_MA0009_201_154_20180306_00106.jpg

LM Start	11.03	Rating **	M	Issue No.	154
LM End	11.03	Issue Type +	En	Location *	LS
Category	Earthen Levee			GPS Latitude/Longitude	
				Start	End
Item	Vegetation			38.438178 °	38.438178 °
				-121.504409 °	-121.504409 °
DWR ID	DWR_MA0009_01_f_2012_154				
Comment Code					
V6 : Landscaping					
Inspector Comment

Agave and shrubs planted on levee slope. Fall 2012

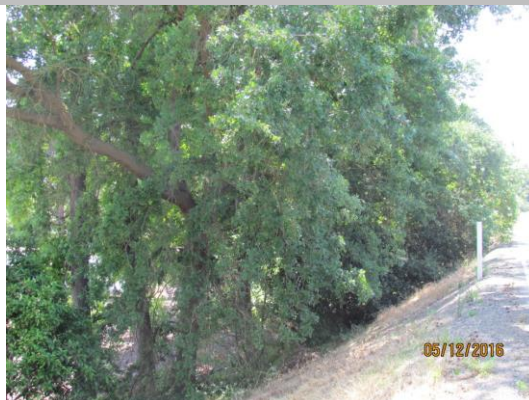
Photo 1 of 1 : SP_2018_MA0009_201_72_20180306_00041.jpg

LM Start	11.19	Rating **	M	Issue No.	72
LM End	11.19	Issue Type +	En	Location *	LS
Category	Earthen Levee			GPS Latitude/Longitude	
				Start	End
Item	Vegetation			38.436735 °	38.436735 °
				-121.506647 °	-121.506647 °
DWR ID	DWR_MA0009_01_f_2012_72				
Comment Code					
V6 : Landscaping					
Inspector Comment

View of the landscape on the landward side of the levee looking downstream. Spring 2016.

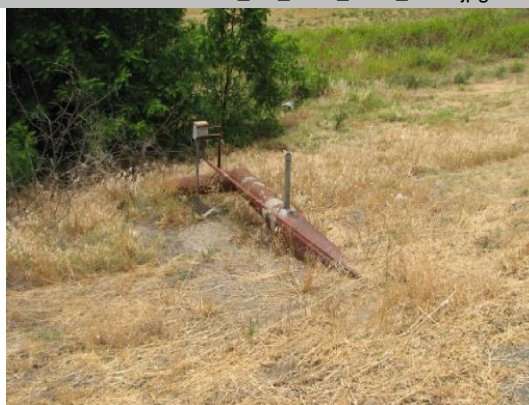
Photo 1 of 3 : UCIP_SP_2018_5129_6861.jpg

Comment Code						
Inspector Comment						
FS_ID:5129						
DS_ID:17457						
EP_NO: N/A						
Repair Type: Non-Urgent						
Crossing Status: Found						
UCIP Comments: Determine if this pipe is grouted in place.						
FIELD_STRUCT_DESC: *ABANDONED* 14-inch pipe through levee, 5.0 feet below-crown. Pump and butterfly valve in pump house on waterward slope. 1.5-inch galvanized steel pipe 5-feet below crown provides electricity. 36-inch Concrete standpipe on LS toe. Permit No. 1215, 1947. included in O+M manual (1955). May have been grouted in place as there are grouting standpipes on both the LS and WS shoulder.						
FS Date: 6/22/2012 2:48:01 PM

14-inch steel pipe on LS slope with 36-inch concrete standpipe in trees at toe.

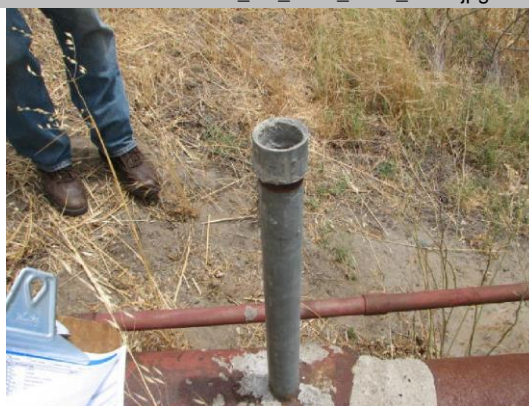
Photo 2 of 3 : UCIP_SP_2018_5129_6860.jpg

Grouting attachment at LS.

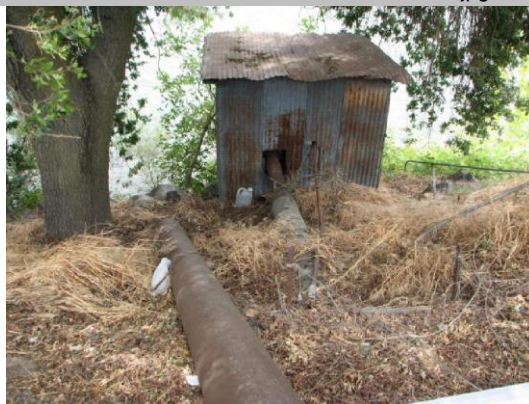
Photo 3 of 3 : UCIP_SP_2018_5129_6859.jpg

pipe and pumphouse on WS slope

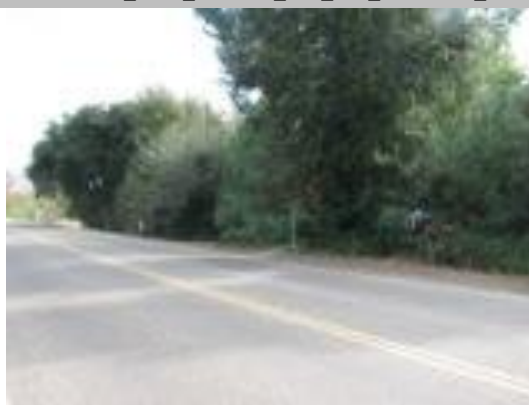
Photo 2 of 2 : SP_2018_MA0009_201_212_20180306_00164.jpg

The landscaping is planted on the levee slope and shoulder. Fall 2011

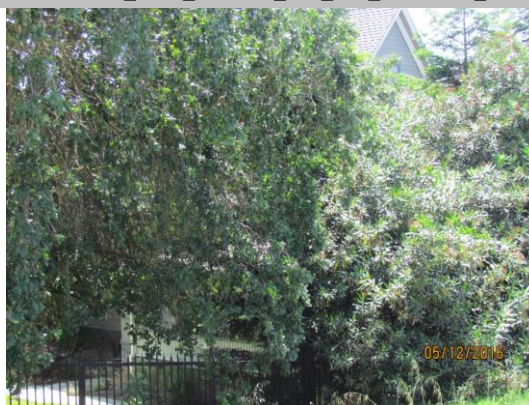
Photo 1 of 1 : SP_2018_MA0009_201_210_20180306_00161.jpg

LM Start	11.54	Rating **	M	Issue No.	210
LM End	11.54	Issue Type +	En	Location *	LS
Category	Earthen Levee			GPS Latitude/Longitude	
				Start	End
Item	Encroachments			38.434465 °	38.434465 °
				-121.512453 °	-121.512453 °
DWR ID	DWR_MA0009_01_s_2012_210				
Comment Code					
BU : Building					
Inspector Comment					
Building with some landscaping in front of it.

View of the building on the landward side of the levee. The building is behind the shrubs and at the toe of the levee. Spring 2016.

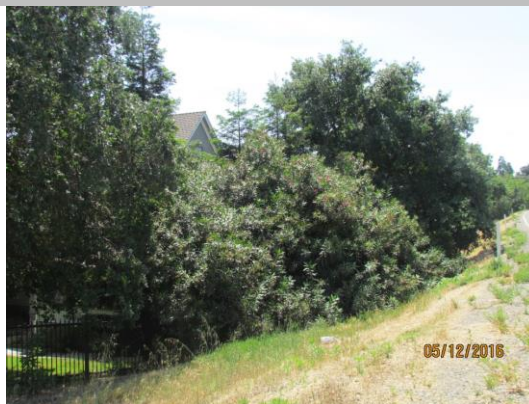
Photo 1 of 1 : SP_2018_MA0009_201_209_20180306_00160.jpg

LM Start	11.55	Rating **	M	Issue No.	209
LM End	11.55	Issue Type +	En	Location *	LS
Category	Earthen Levee			GPS Latitude/Longitude	
				Start	End
Item	Vegetation			38.434413 °	38.434413 °
				-121.512623 °	-121.512623 °
DWR ID	DWR_MA0009_01_s_2012_209				
Comment Code					
V6 : Landscaping					
Inspector Comment

View of the landscaping on the landward side of the levee looking downstream. Spring 2016.

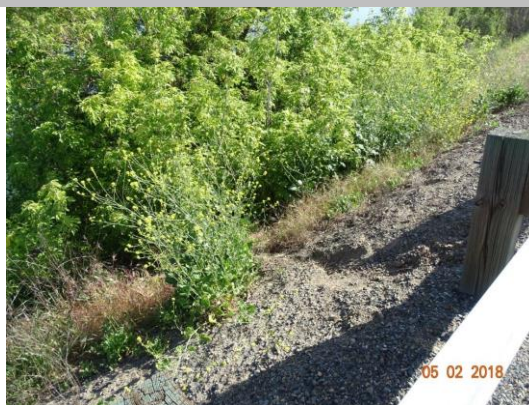
Photo 1 of 1 : SP_2018_MA0009_201_262_20180502_00524.jpg

LM Start	11.62	Rating **	A/W	Issue No.	262
LM End	11.62	Issue Type +	Ma	Location *	WS
Category	Earthen Levee			GPS Latitude/Longitude	
				Start	End
Item	Erosion / Bank Caving			38.434149 °	38.434149 °
				-121.513969 °	-121.513969 °
DWR ID	DWR_MA0009_01_s _ 2018_262				
Comment Code					
E1 : Note and monitor erosion site.					
Inspector Comment					
Minor runoff on the waterside slope. Recommend monitoring.

View of erosion on the waterside slope. Spring 2018.

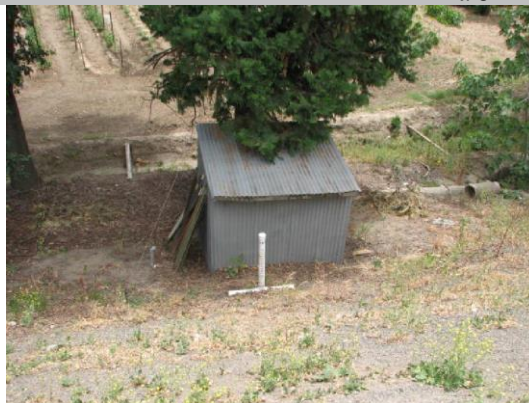
Photo 1 of 3 : UCIP_SP_2018_5133_6876.jpg

LM Start	11.66	Rating **	M	Issue No.	1816
LM End	11.66	Issue Type +	En	Location *	
Category	Supplemental			GPS Latitude/Longitude	
				Start	End
Item	DWR UCIP Field Study			38.434075 °	38.434075 °
				-121.514687 °	-121.514687 °
DWR ID					
Comment Code					
Inspector Comment					
FS_ID:5133 DS_ID:17461 EP_NO: N/A Repair Type: Non-Urgent Crossing Status: Found UCIP Comments: excessive brush on WS slope prevents access to gate valve on WS slope. Remove brush. FIELD_STRUCT_DESC: 6-inch pipe through levee, 16.5 feet below crown. Pump in pump house at toe of landward slope. Could not locate the gate valve on waterward slope. Originally included in O+M manual (1955). FS Date: 6/22/2012 3:08:19 PM

Pumphouse on LS toe.

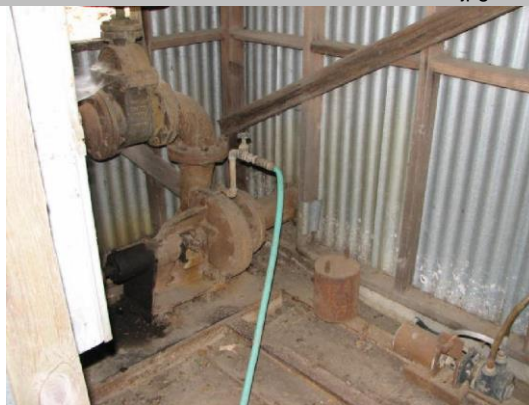
Photo 2 of 3 : UCIP_SP_2018_5133_6875.jpg

Pump in pumphouse on LS toe.

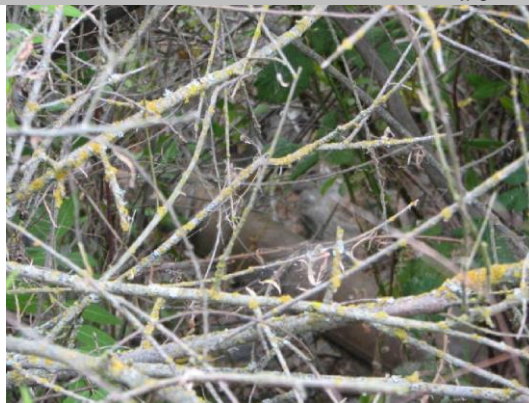
Photo 3 of 3 : UCIP_SP_2018_5133_6874.jpg

Brush covered pipe on WS slope.

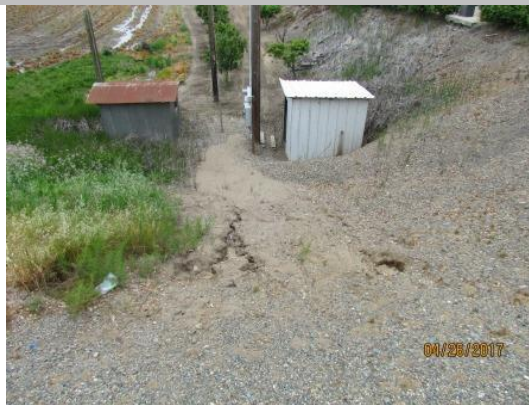
Photo 1 of 1 : SP_2018_MA0009_201_374_20180306_00301.jpg

LM Start	11.77	Rating **	A/W	Issue No.	374
LM End	11.77	Issue Type +	Ma	Location *	LS
Category	Earthen Levee			GPS Latitude/Longitude	
				Start	End
Item	Erosion / Bank Caving			38.433958 °	38.433958 °
				-121.516706 °	-121.516706 °
DWR ID	DWR_MA0009_01_s_2017_374				
Comment Code					
E2 : Schedule repair of erosion site prior to the next inspection.					
Inspector Comment					
Runoff erosion on landside levee slope.

View of erosion on landside levee slope. Spring 2017.

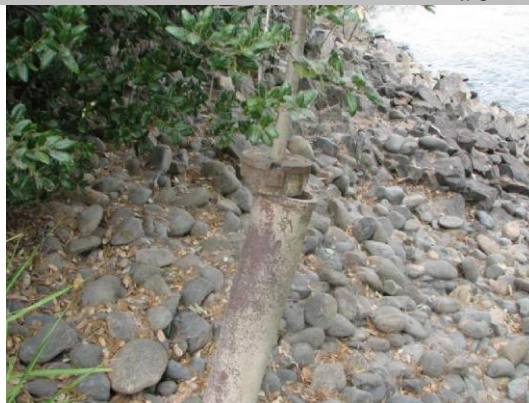
Photo 1 of 3 : UCIP_SP_2018_5139_6899.jpg

LM Start	11.78	Rating **	M	Issue No.	1817
LM End	11.78	Issue Type +	En	Location *	
Category	Supplemental			GPS Latitude/Longitude	
				Start	End
Item	DWR UCIP Field Study			38.433998 °	38.433998 °
				-121.516790 °	-121.516790 °
DWR ID					
Comment Code					
Inspector Comment					
FS_ID:5139 DS_ID:17673 EP_NO: N/A Repair Type: Non-Urgent Crossing Status: Found UCIP Comments: valve on WS slope does not close. FIELD_STRUCT_DESC: 2 of 2: 6-inch pipes through levee, 15.6 feet below crown. Pump and gate valve in pump house on landward side. Gate valve on WS slope. Originally included in O+M manual (1955). FS Date: 6/22/2012 3:31:00 PM

Broken or rusted valve on WS slope.

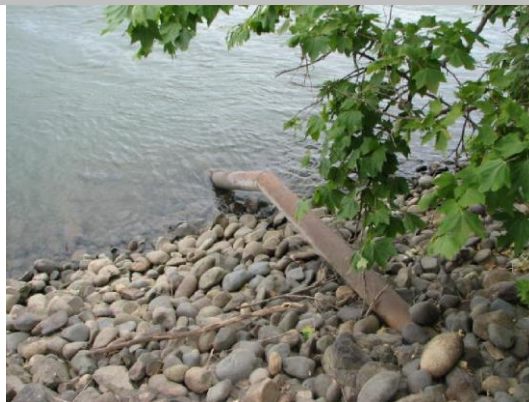
Photo 2 of 3 : UCIP_SP_2018_5139_6898.jpg

Pipe on WS slope.

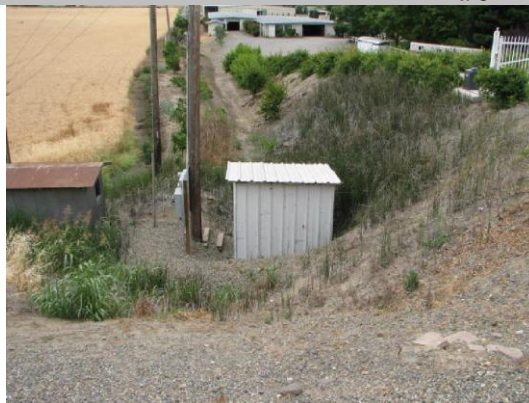
Photo 3 of 3 : UCIP_SP_2018_5139_6897.jpg

Pumphouse on LS toe with JP and meter.

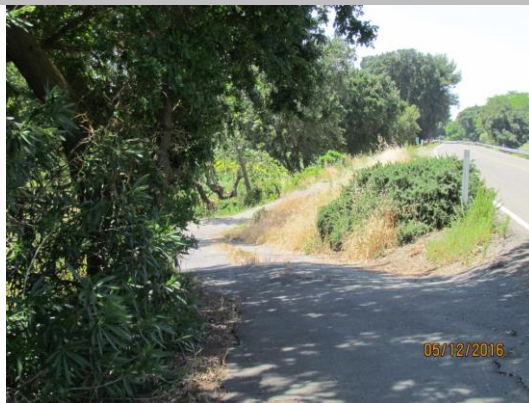
Photo 1 of 1 : SP_2018_MA0009_201_208_20180306_00159.jpg

LM Start	12.00	Rating **	M	Issue No.	208
LM End	12.00	Issue Type +	En	Location *	LS
Category	Earthen Levee			GPS Latitude/Longitude	
				Start	End
Item	Vegetation			38.433977 °	38.433977 °
				-121.520955 °	-121.520955 °
DWR ID	DWR_MA0009_01_s_2012_208				
Comment Code					
V6 : Landscaping					
Inspector Comment

View of the bush on the landward side of the levee looking downstream. Spring 2016.

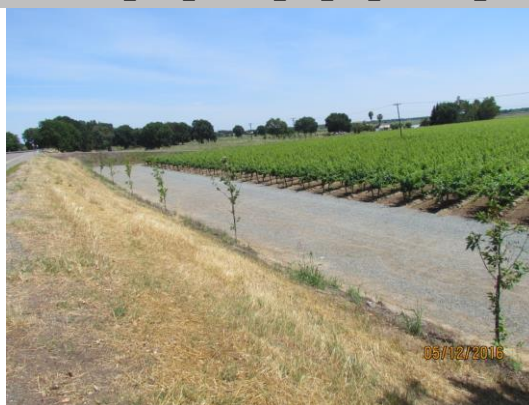
Photo 1 of 1 : SP_2018_MA0009_201_384_20180306_00308.jpg

LM Start	12.33	Rating **	M	Issue No.	384
LM End	12.37	Issue Type +	En	Location *	LS
Category	Earthen Levee			GPS Latitude/Longitude	
				Start	End
Item	Vegetation			38.433822 °	38.433665 °
				-121.526819 °	-121.527565 °
DWR ID	DWR_MA0009_01_s _ 2016_384				
Comment Code					
V6 : Landscaping					
Inspector Comment					
7 trees planted at levee toe.

View of the newly planted trees at the toe of the levee on the landward side looking upstream. Spring 2016.

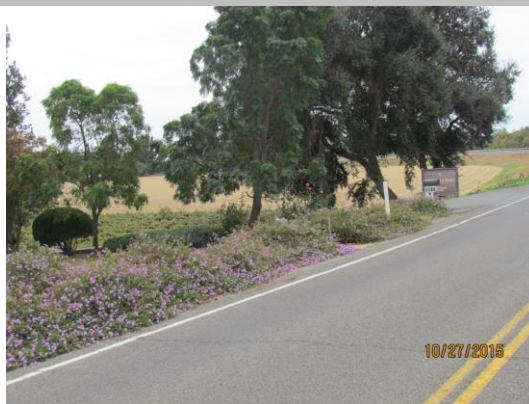
Photo 1 of 1 : SP_2018_MA0009_201_225_20180306_00168.jpg

LM Start	12.40	Rating **	M	Issue No.	225
LM End	12.40	Issue Type +	En	Location *	LS
Category	Earthen Levee			GPS Latitude/Longitude	
				Start	End
Item	Vegetation			38.433536 °	38.433536 °
				-121.528237 °	-121.528237 °
DWR ID	DWR_MA0009_01_s _ 2012_225				
Comment Code					
V6 : Landscaping					
Inspector Comment

View of the groundcover on the landward side of the levee looking downstream. Fall 2015.

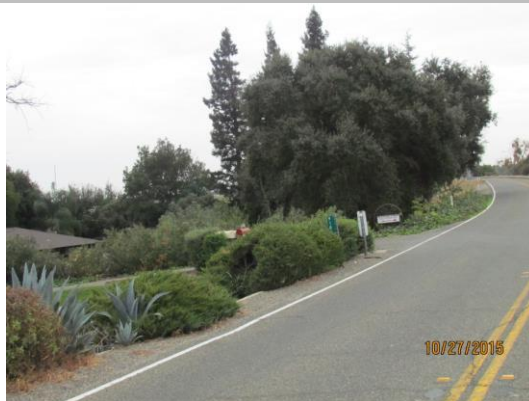
Photo 1 of 1 : SP_2018_MA0009_201_207_20180306_00158.jpg

LM Start	12.76	Rating **	M	Issue No.	207
LM End	12.76	Issue Type +	En	Location *	LS
Category	Earthen Levee			GPS Latitude/Longitude	
				Start	End
Item	Vegetation			38.429764 °	38.429764 °
				-121.531226 °	-121.531226 °
DWR ID	DWR_MA0009_01_s_2012_207				
Comment Code					
V6 : Landscaping					
Inspector Comment

View of the landscaping on the landward side of the levee looking downstream. Fall 2015.
